Final Report

EgyptAir Boeing 777-200 aircraft cockpit fire

AT Cairo Airport

On 29th July 2011

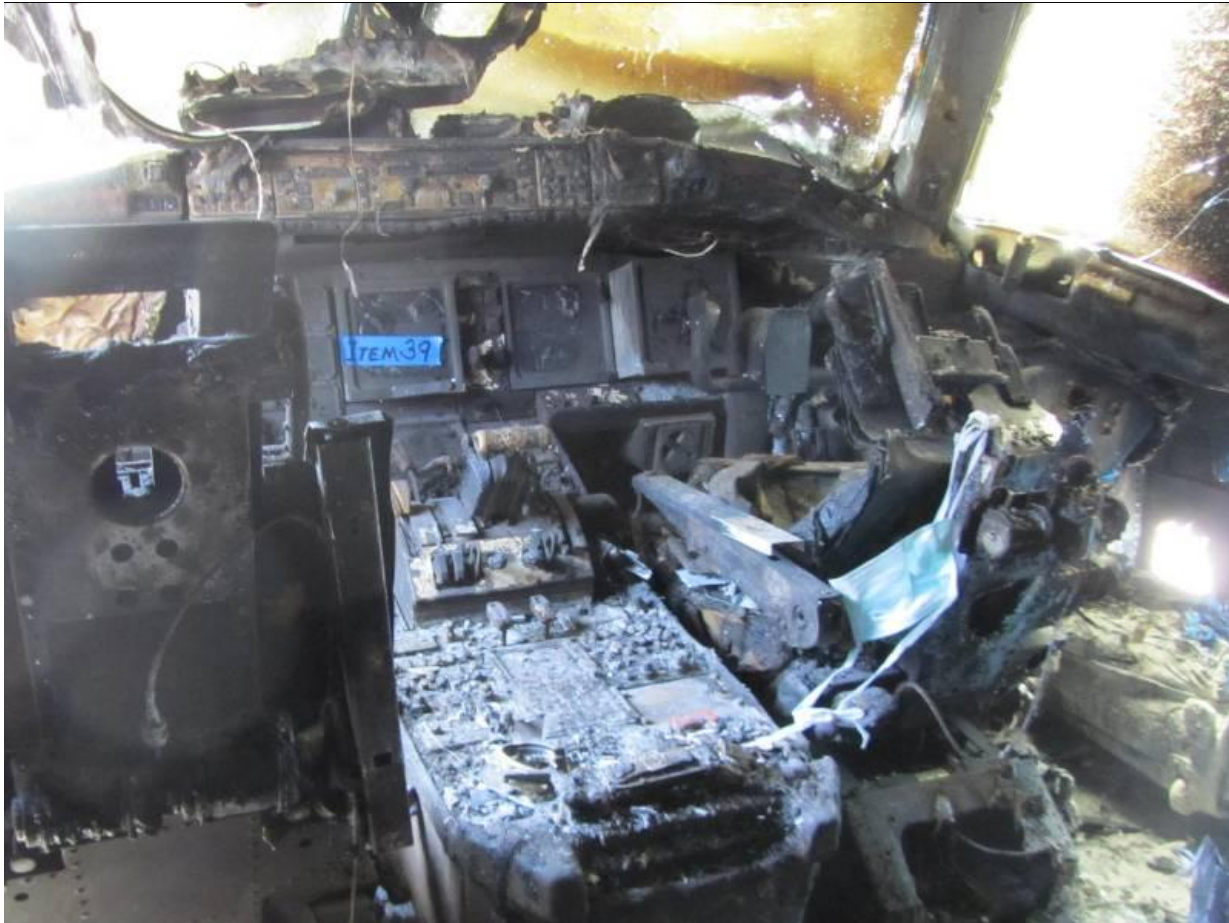
Examination of the aircraft determined that the cockpit was extensively damaged, and two holes were burned through the aircraft external skin just below the First Officer's window.

In addition, smoke damage occurred throughout the aircraft, and heat damage was found on overhead structures well aft of the cockpit.

Isolated areas of heat damage were found in the forward electronics bay located below the flight deck in locations where molten metal had dripped down from the main deck.

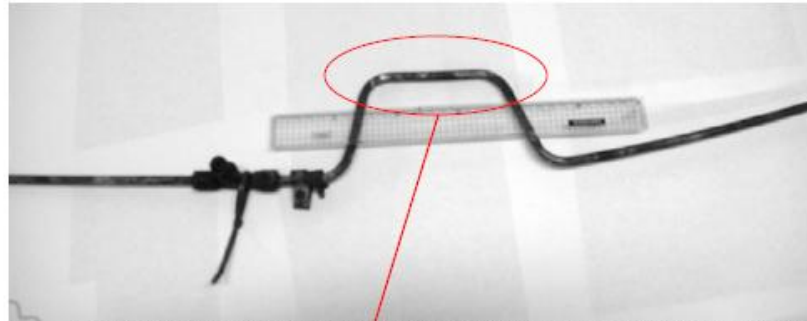
Fig. 1 General View of the received stainless steel supply tube

The tube surface was covered by fire products, and some areas have rough surface. The molten metal is basically aluminum alloy, resulted from the fire.

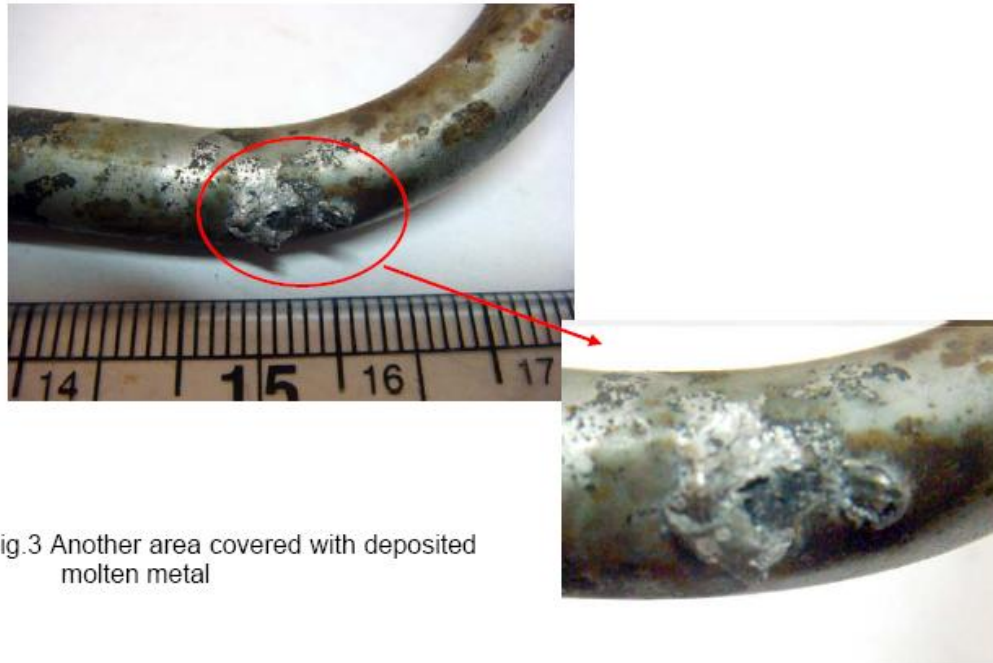
Fig.3 Another area covered with deposited molten metal

No leakage areas were detected throughout the length of the tube.

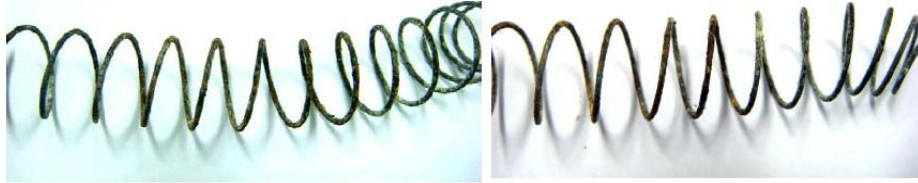
The stainless steel spring surface was covered by fire products with some spot rusted area (red color). No direct evidence of a short circuit was found, but most of the wiring near the supply tubing and portions of the tubing were missing, with evidence of melting on the remaining portions.

According to CMRDI view, most plausible cause for the observed melting of the stainless steel spring assembly is an oxygen fuel flame caused by high attained temperatures

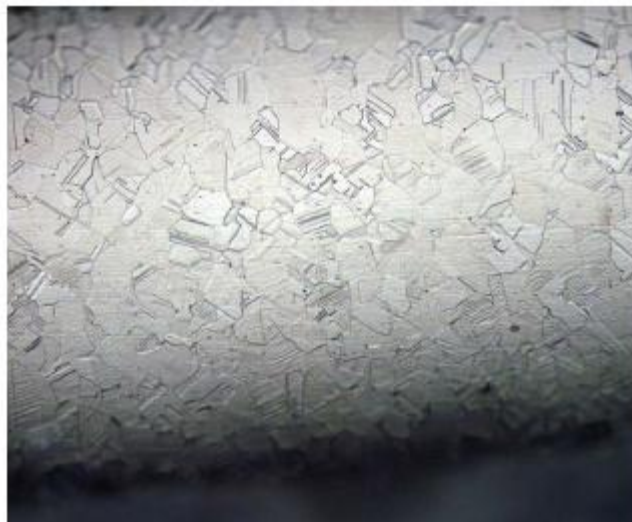
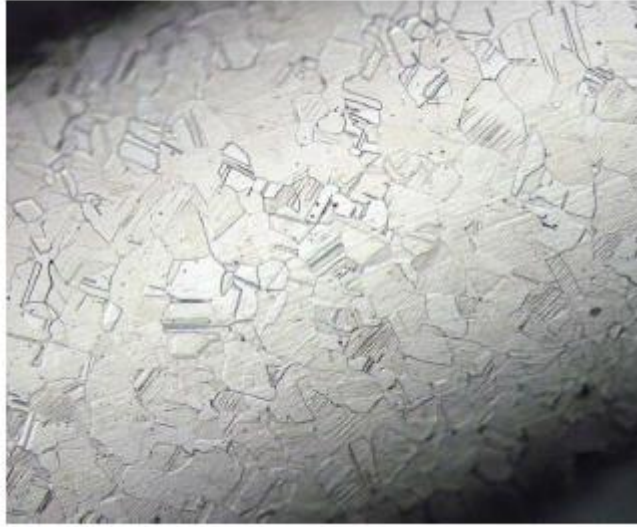
Microstructure of the investigated stainless steel spring, 200X

The microstructure is normal for this type of stainless steel with normal grain size and without any precipitates.

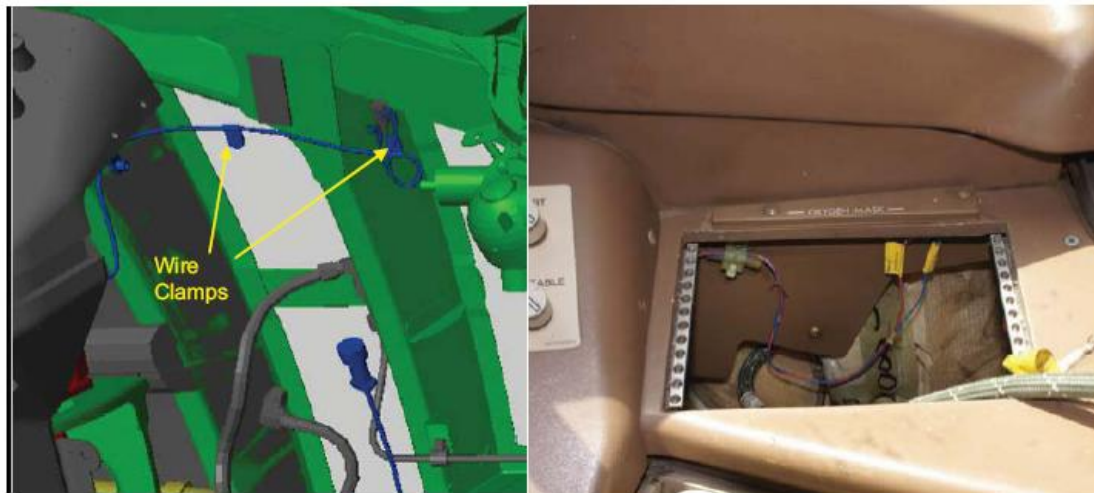
Current Design As found on a different 777-200

The 777-200 aircraft were found to differ from Boeing's current design. In particular, the wiring to the first officer's oxygen mask light plate differed in the follow aspects: a wire clamp was missing, the wiring was not sleeved, and a large loop of unsupported wire was found. All of EgyptAir's 777-200 had a similar wiring configuration at the first officer's oxygen mask location. The captain's side wiring was similar, except that sleeving was present on all airplanes inspected.

1. Released Service Bulletin 777-33-0042, dated 9 January 2012, recommending that 777 operators inspect and if necessary repair the captain's and first officer's oxygen light plate wiring.
2. Revised 777 new production to replace low pressure oxygen hoses with non-conductive low pressure oxygen hoses located in the flight deck. The first new airplane with non-conductive hoses was delivered in November 2011.
3. Released Alert Service Bulletin 777-35A0027, dated 15 December 2011, recommending that operators of previously delivered 777 airplanes replace low pressure oxygen hoses with non-conductive low pressure oxygen hoses located in the flight deck.
4. Provided information to 777 operators regarding the progress of the investigation and the changes described above (in coordination and with the approval of the EMCA).

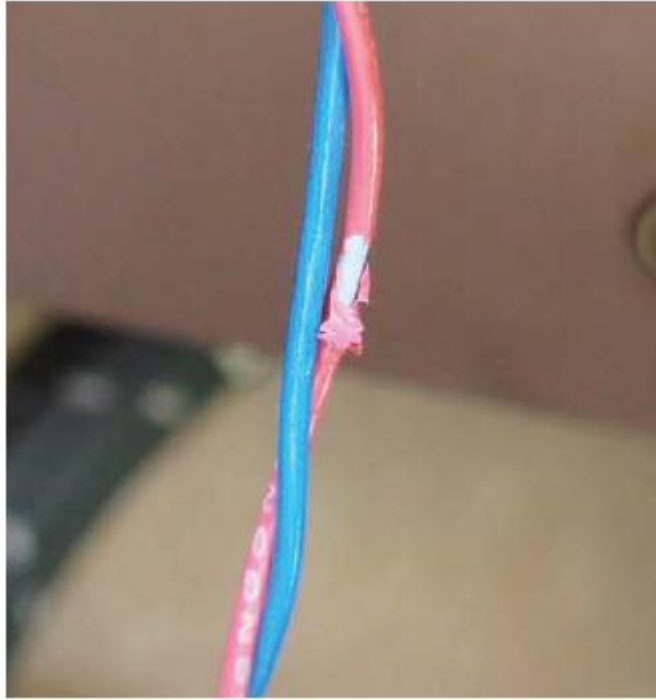
On one of the 777-200 aircraft, the outer layer of wiring insulation was found damaged, although the inner layer was intact and the conductor was not exposed.

Damaged first officer oxygen light plate 5 volt AC wiring on a different 777-200 airplane

It was later determined that approximately 380 early 777 aircraft (including the accident) had been produced without sleeving on this wire run. Although the missing clamp was found on a number of 777-200 aircraft, the reason for the missing clamps could not be determined as the clamps have been part of the original design of the 777 aircraft. Boeing determined that it was appropriate to install sleeving on these wires and released a Service Bulletin (777-33-0042, dated 9 January 2012) recommending that 777 operators inspect and if necessary repair the captain's and first officer's oxygen light plate wiring.

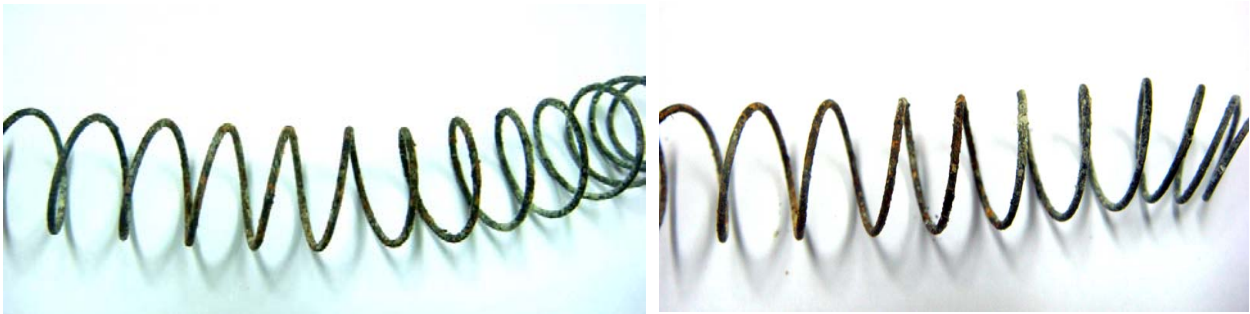
Sample No.5: Anti Kink Spring Supply Hoses Floor to Tee F/O O₂ (Stainless Steel Spring)

The stainless steel spring surface is covered by fire products with some spot rusted area (red color). No direct evidence of a short circuit was found, but most of the wiring near the supply tubing and portions of the tubing were missing.

The only way to cause melting of the stainless steel spring assembly is an oxygen-fuel flame because temperatures that are attained in ordinary fires are not sufficient to melt stainless steel. The source of oxygen to allow for this melting would have had to be located closely to the melted stainless steel spring assembly; thus, the source of oxygen was the flexible oxygen hose connected to that particular spring assembly.

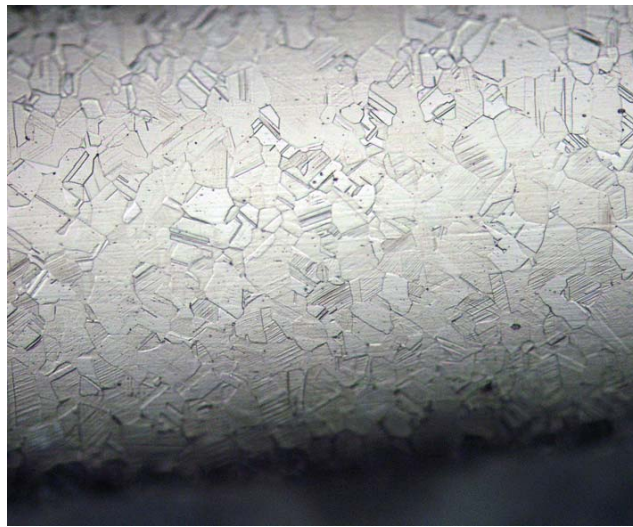
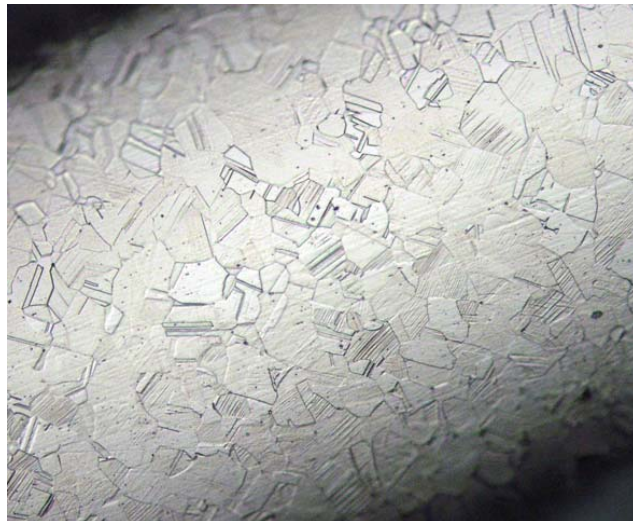
Microstructure of the investigated stainless steel spring, 200X

This could be approved from the metallurgical microstructure of stainless steel wire, investigated at different places. The microstructure is normal for this type of stainless steel with normal grain size and without any precipitates, as shown in the following figure. If the heating of the stainless steel spring took long time the microstructure will be coarser and different type of precipitates will be observed on the grain boundaries, which is not our case.

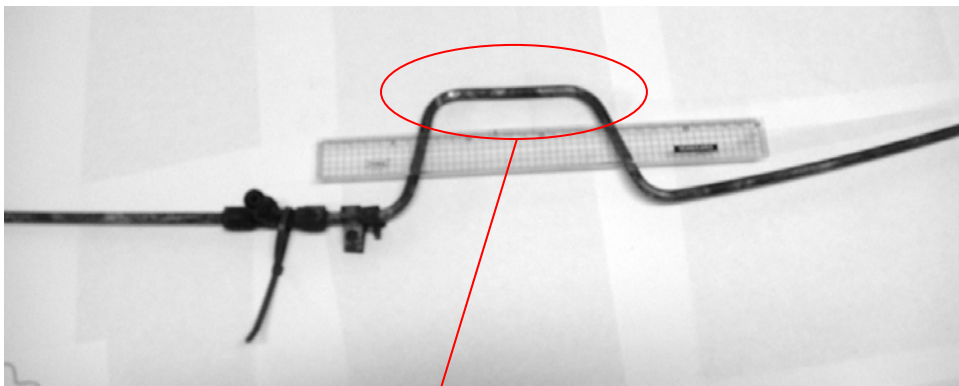
Fig. 1 General View of the received stainless steel supply tube

The tube surface was covered by fire products, as shown in Fig.2, and some areas have rough surface. The deposited molten metal shown in Fig.2, was send to chemical analysis. The molten metal is basically aluminum alloy, resulted from the fire.

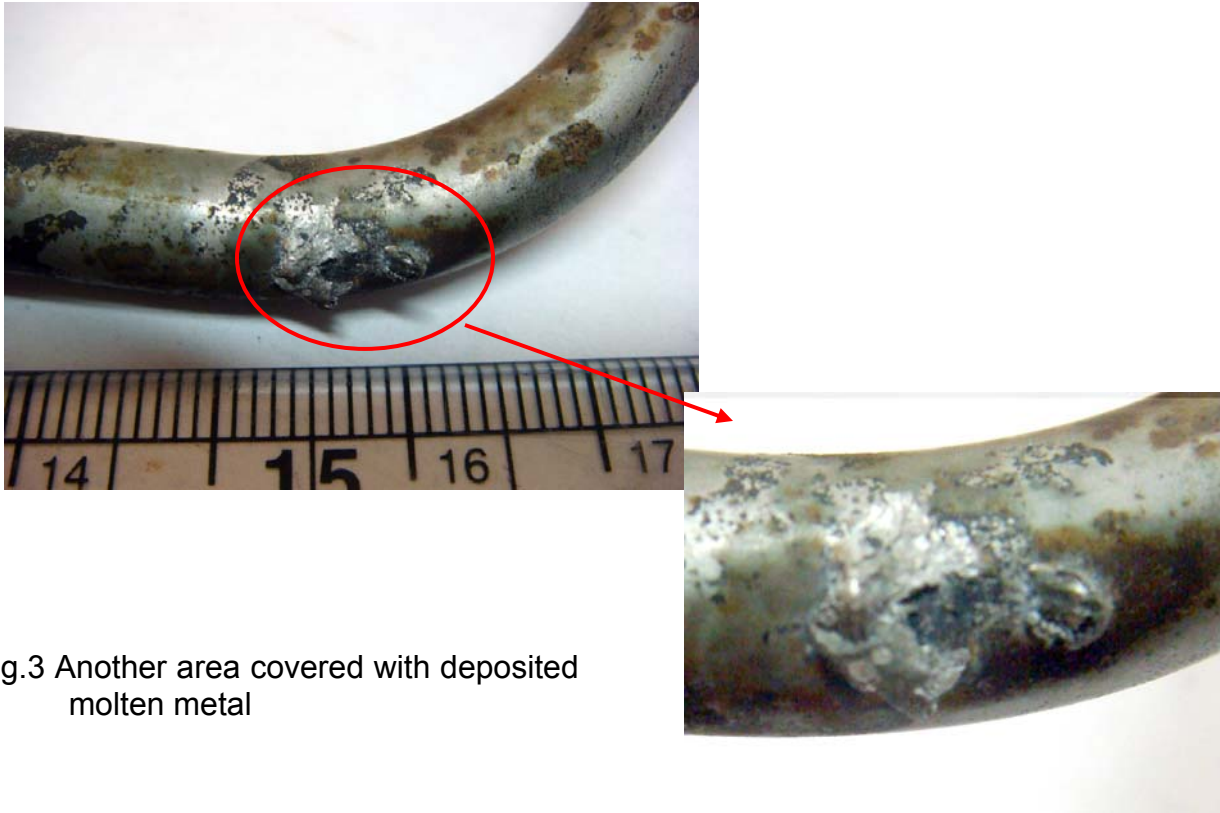
Fig.3 Another area covered with deposited molten metal

Another area was noted as shown in Fig.3, with suspected spot as an arc strike. Detail investigation showed that this is also covered only with deposited molten metal.

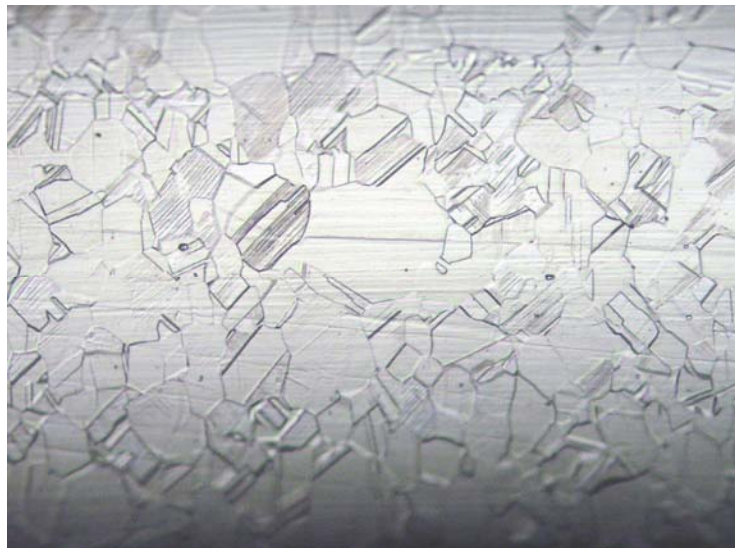
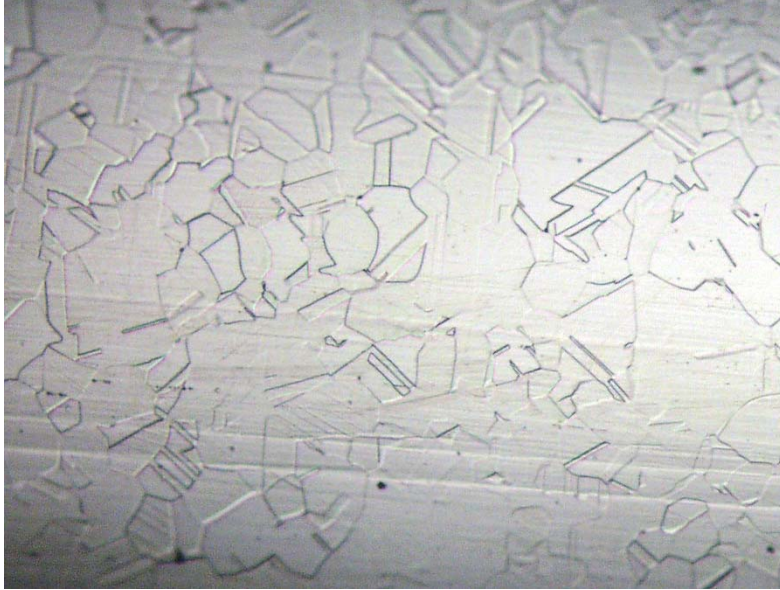
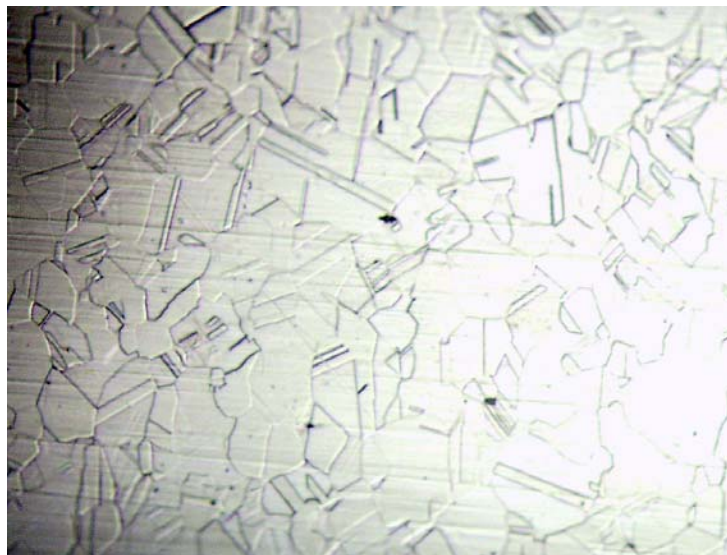
Microstructure of the investigated stainless steel spring, 200X

It is supposed that the stainless steel spring had been subjected to high energy level, which heated the internal spring until it became an ignition energy source, causing the flexible oxygen hose to ignite and sustain a fire. The time to failure, may took few seconds depending on the amount of energy supplied to the internal spring.

This could be approved from the metallurgical microstructure of stainless steel wire, investigated at different places. The microstructure is normal for this type of stainless steel with normal grain size and without any precipitates, as shown in the following figures. If the heating of the stainless steel spring took long time the microstructure will be coarser and different type of precipitates will be observed on the grain boundaries, which is not our case.
