Final Report

EgyptAir Boeing 777-200 aircraft cockpit fire

AT Cairo Airport

On 29th July 2011

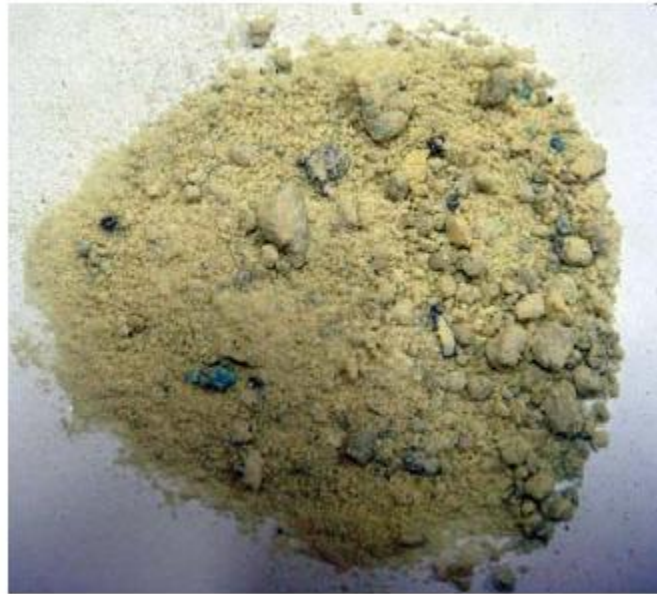
Sample No.1: Yellow Powder (Flight Deck R.H.S. SU-GBP)

The test results showed that the yellow powder is mainly consists from Sulfaguanidine $C_7H_{10}N_4O_2S$ and Mascagnite $(NH_4)_2SO_4$.

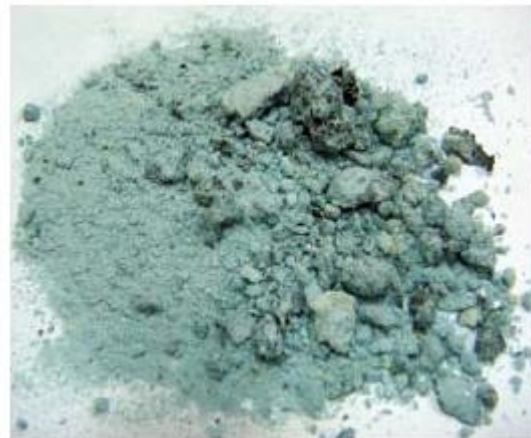
*Sample No.2: Blue Powder (Flight Deck R.H.S.)

The test results showed that the blue powder mainly consists of Mascagnite $(NH_4)_2SO_4$ and Barite $BaSO_4$.

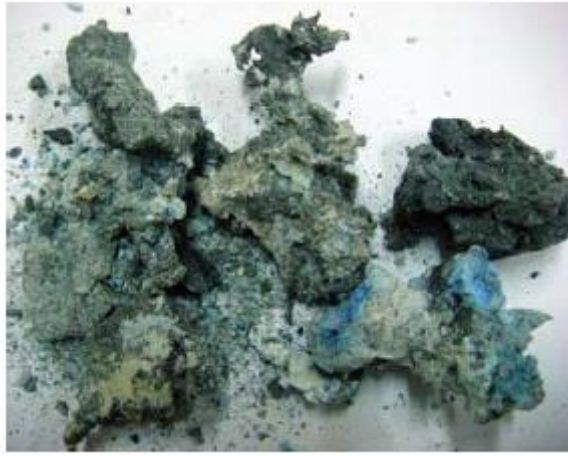
Sample No.3: Charred Material and Powder (R.H.S.)

The test results showed that the charred material mainly consists of Iron ammonium Nicotinate N-Oxide Sulfate Decahydrate $C_{21}H_{31}FeN_7O_{17}S_2 \cdot 10H_2O$, Aluminum Boron Molybdenum Oxide $B_3.26Al_4MoO_{14.96}$ and Hydrogen Deuterium Aluminum Silicate. $(H_{0.13}D_{0.87})(AlSi_2O_6)$.

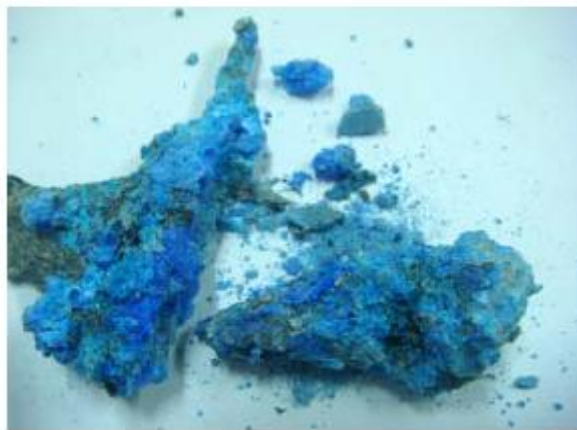
Sample No.4: Bright Blue Material (Flight Deck R.H.S. AFT of Main hole Adjacent to Wiring).

The test results showed that the bright blue material mainly consists of Mascagnite ($\text{NH}_4\text{)}_2\text{SO}_4$.

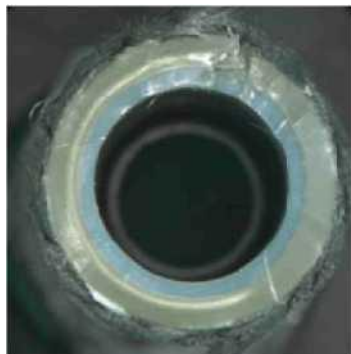
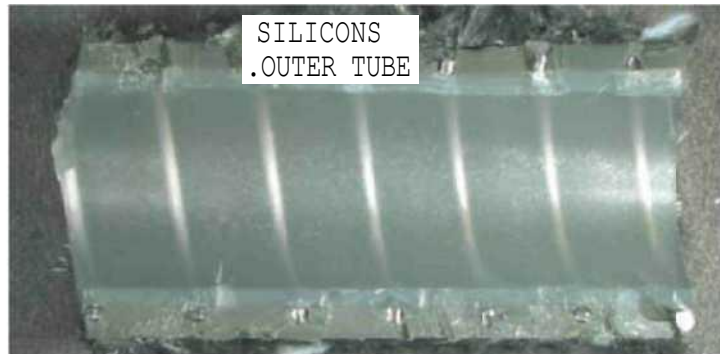
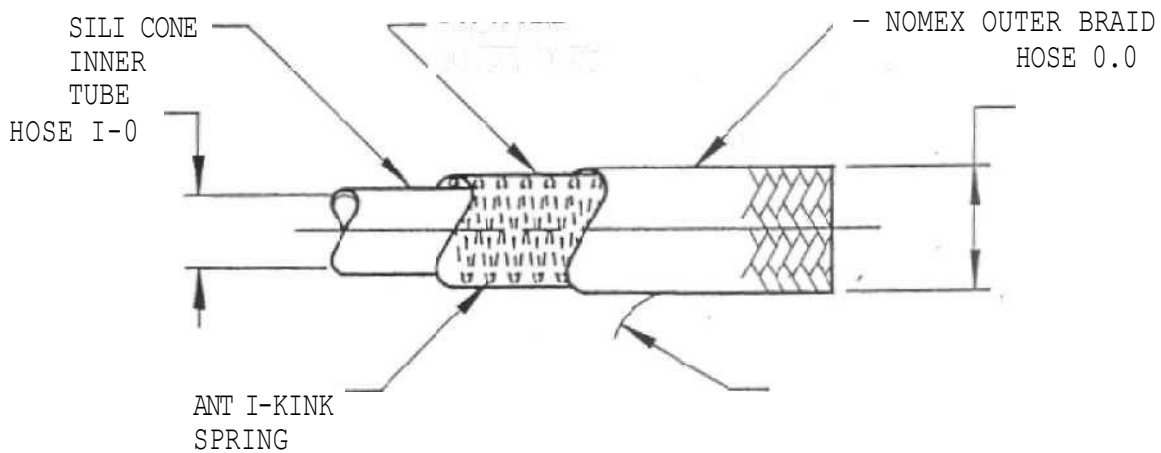
Flexible Oxygen Hose Construction

The hoses tested by the NTSB in 2008/2009 were of comprised of clear polyvinyl chloride (PVC) with an internal stainless steel anti-kink spring. The hoses used on accident airplane (SU-GBP) were different in that they were comprised of two layers of silicon tubing with the anti-kink springs embedded in the outer layer.

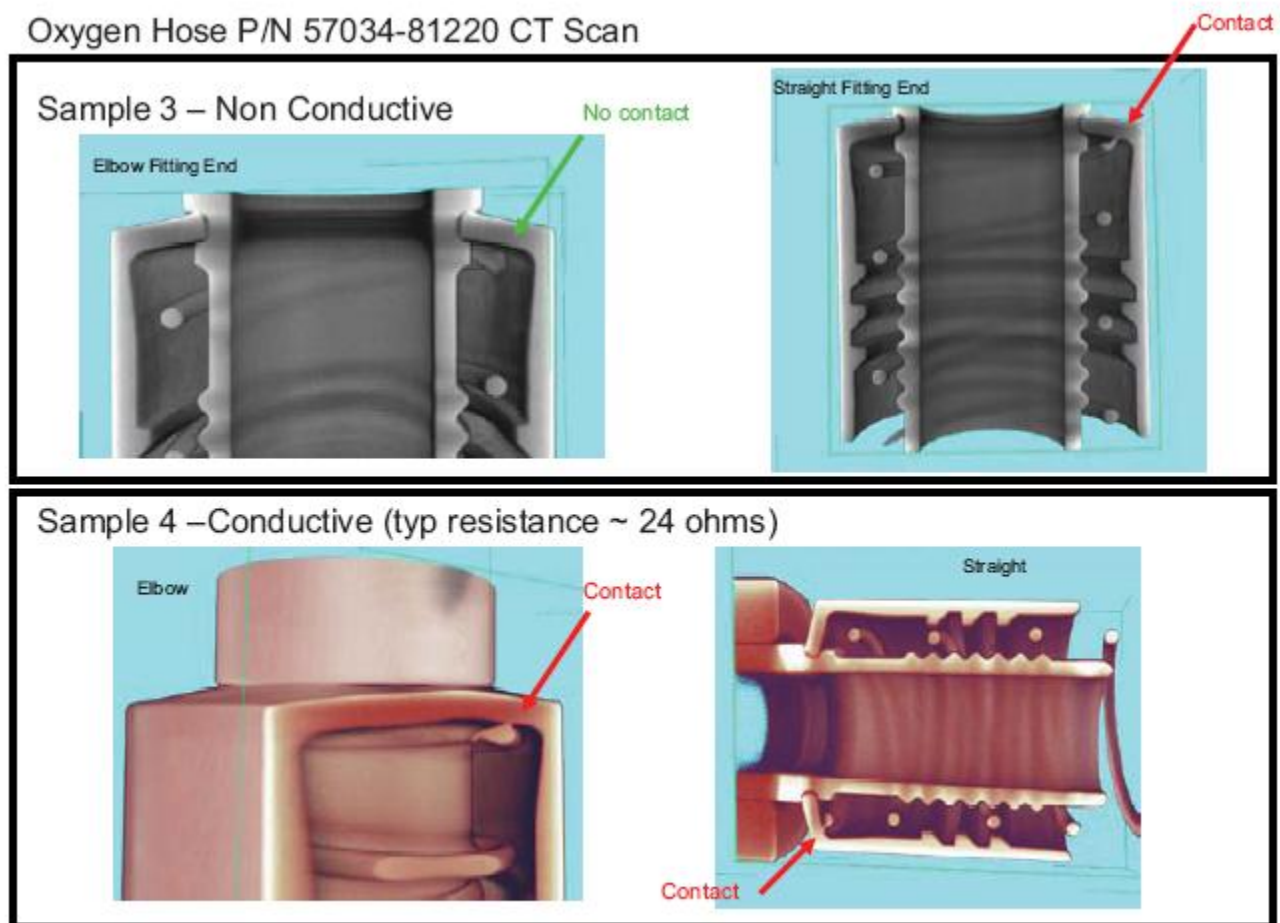
Hose End CT Scan Images

The hoses used in the manufacture of the 777 do not have any design requirements related to conductivity. Seven exemplar flexible oxygen hoses were tested for conductivity. Of the seven hoses tested, two were found to be conductive and the remainder were non-conductive. The hose end fittings were imaged via computed tomography (CAT scan) to determine the reason for the variability. Variations were found in the details of the cut end of the hose. Specifically, in some samples, the cut end of the embedded spring was in contact with the end fitting and in other cases it was not. The two hoses that were found to be conductive had both ends of the spring in contact with their respective end fittings. Some of the non-conductive samples were found to have one end of the spring in contact with the end fitting, but were not conductive because the other end was not in contact.

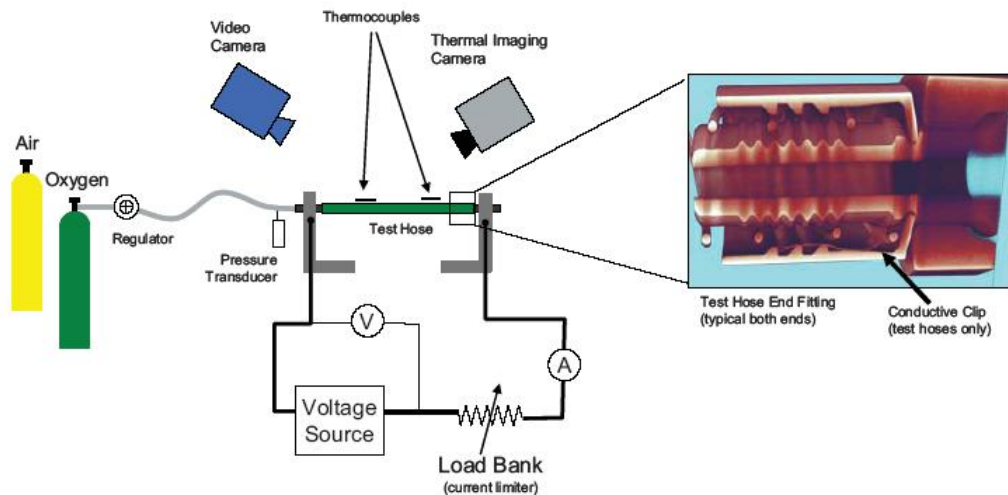
Flexible Oxygen Hose Test Setup

As shown in the diagram, the voltage was measured across the test hose and load bank connected in series and thus represents the combined voltage across both. The actual voltage across the hose by itself was lower than the measured value.

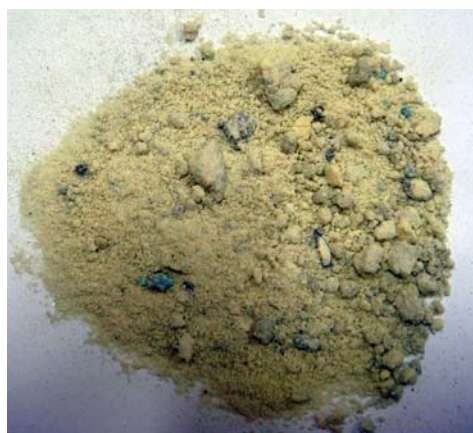
Sample No.1: Yellow Powder (Flight Deck R.H.S. SU-GBP)

The test results showed that the yellow powder is mainly consists from Sulfaguanidine $C_7H_{10}N_4O_2S$ and Mascagnite $(NH_4)_2SO_4$.

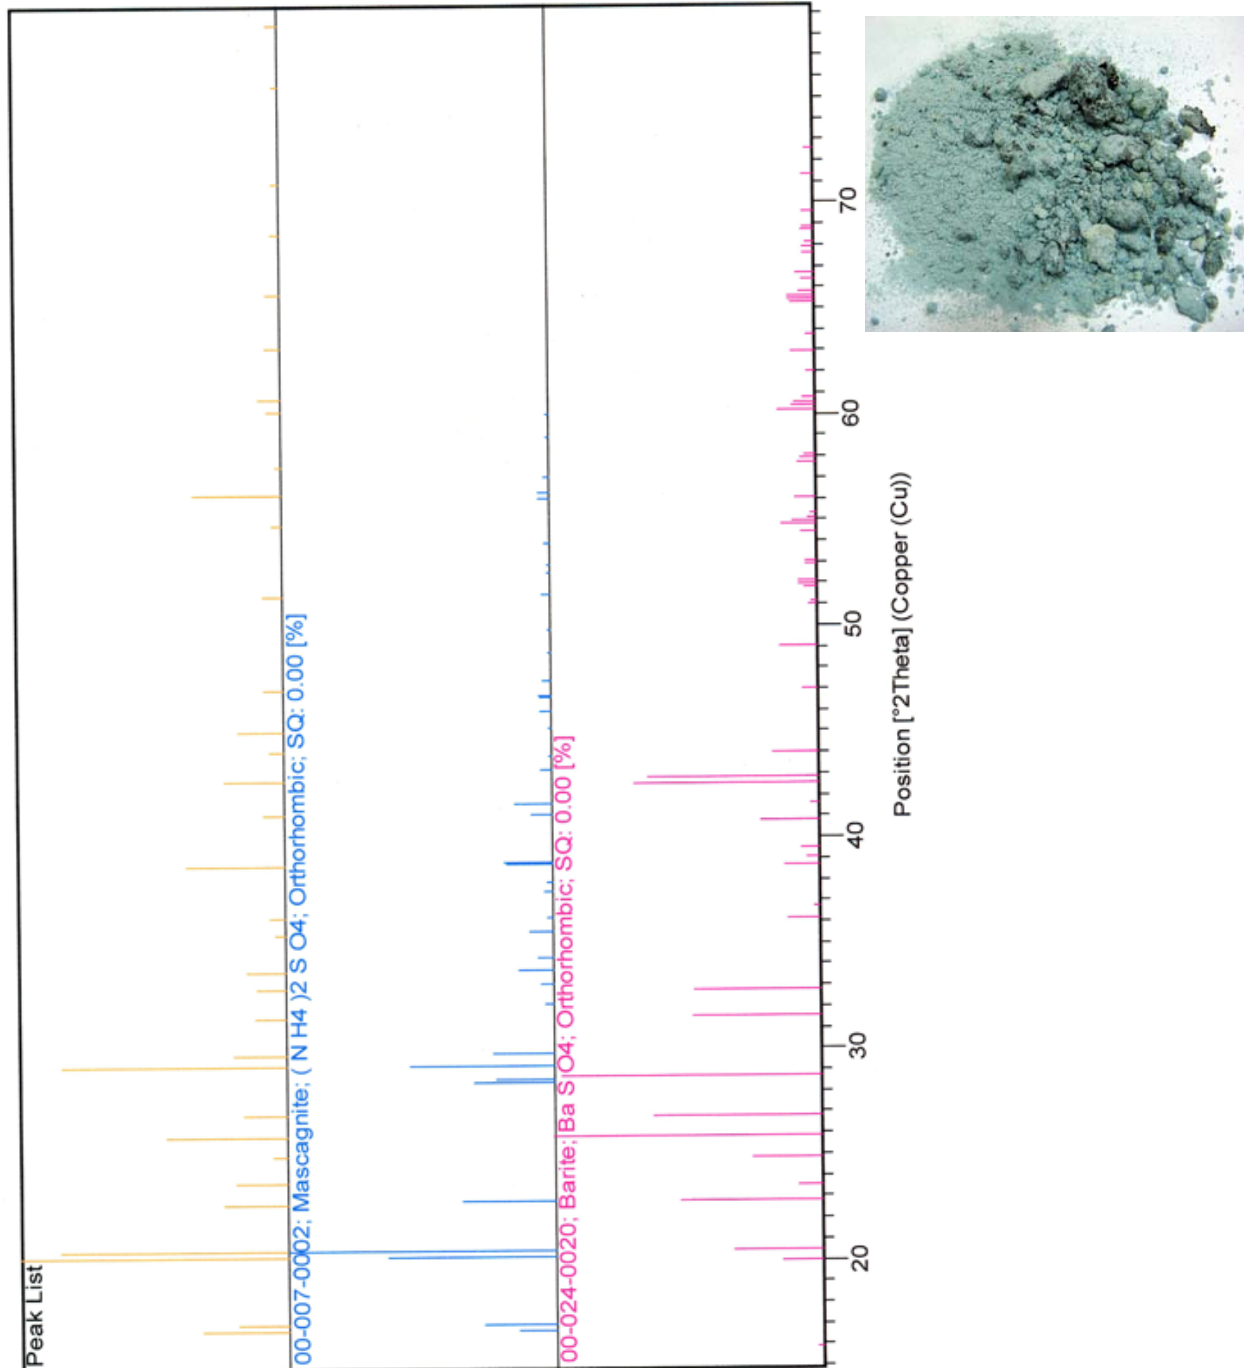
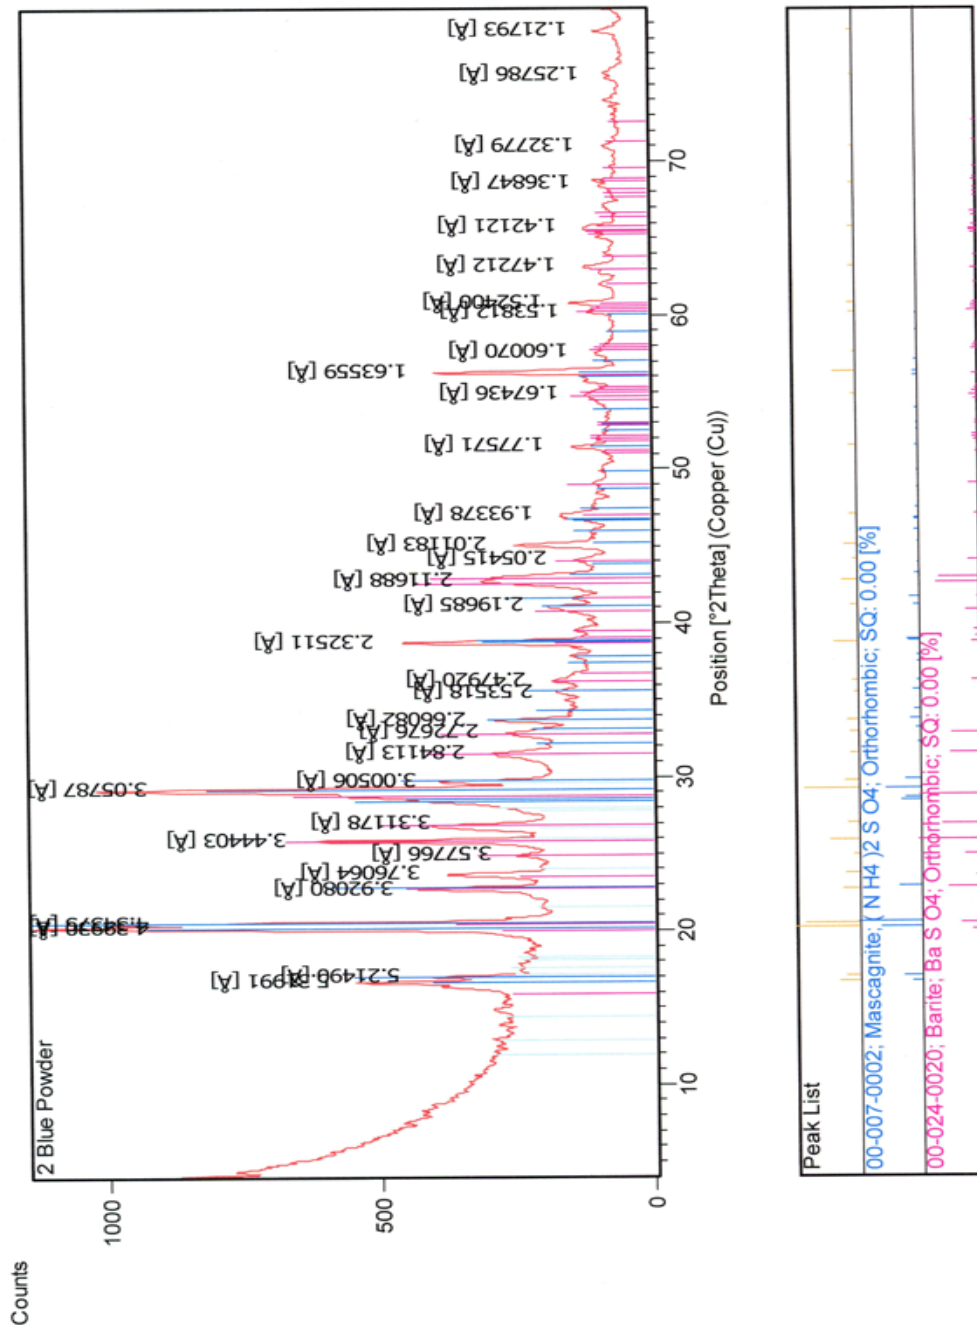
Sample No.2: Blue Powder (Flight Deck R.H.S. SU-GBP)

The test results showed that the blue powder is mainly consists of Mascagnite (NH₄)₂SO₄ and Barite BaSO₄.

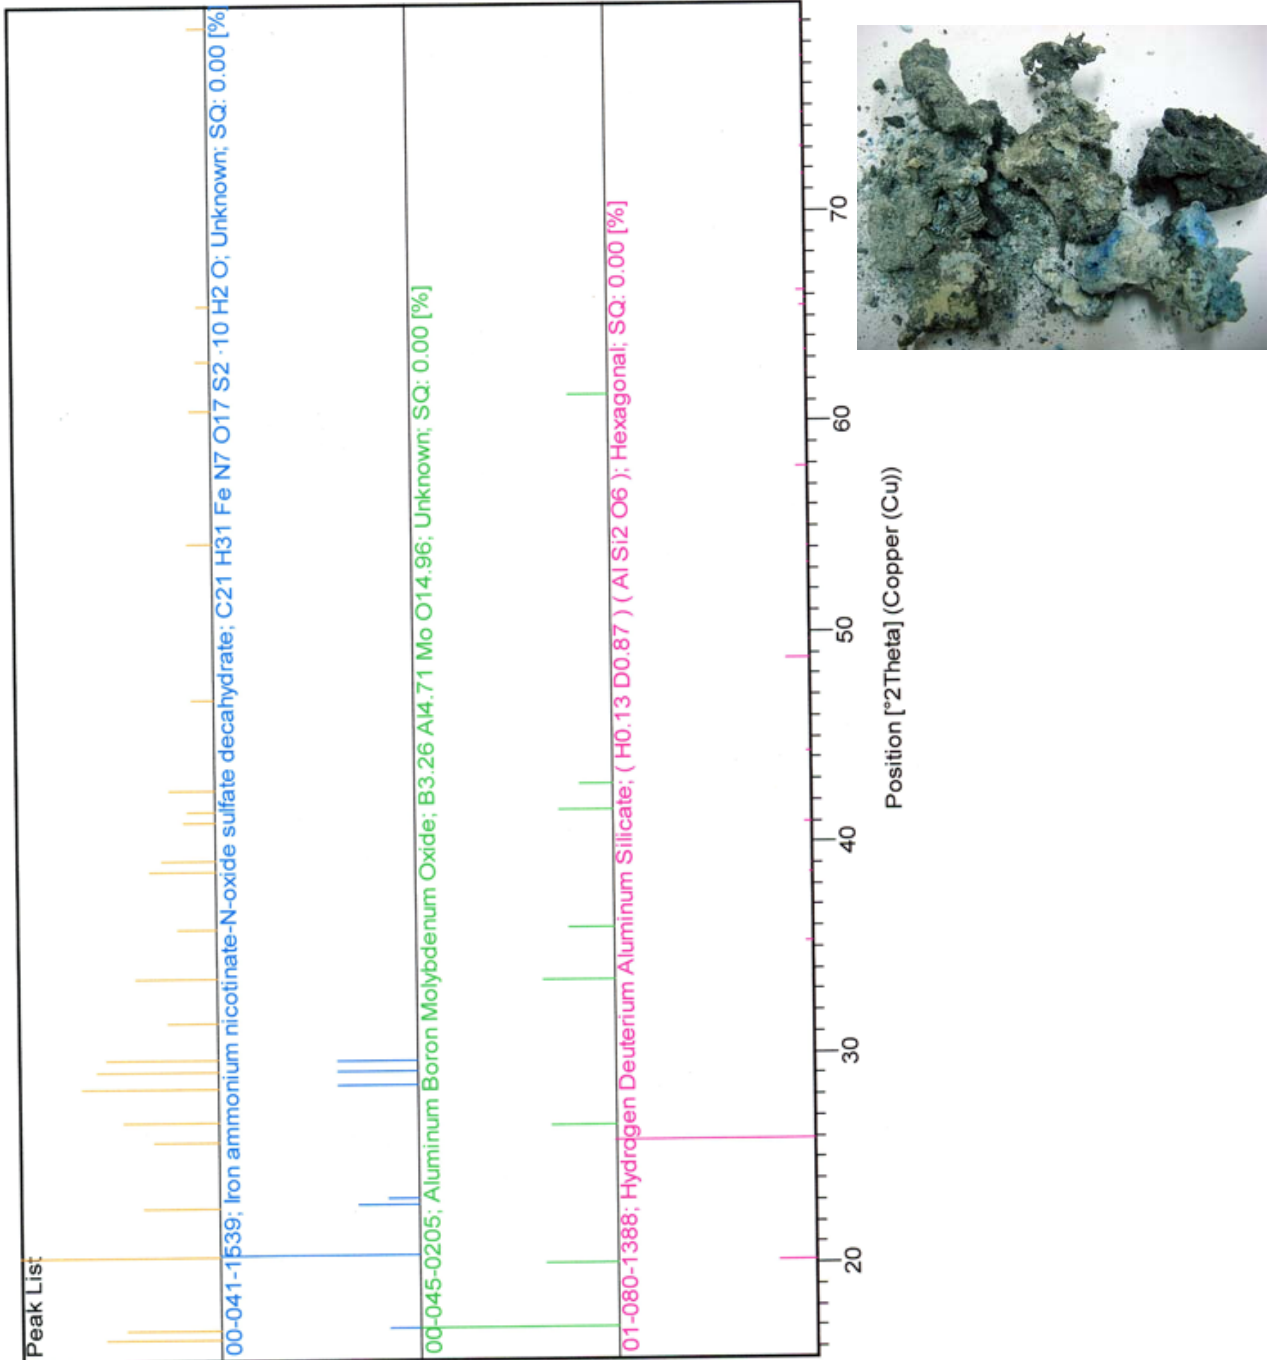
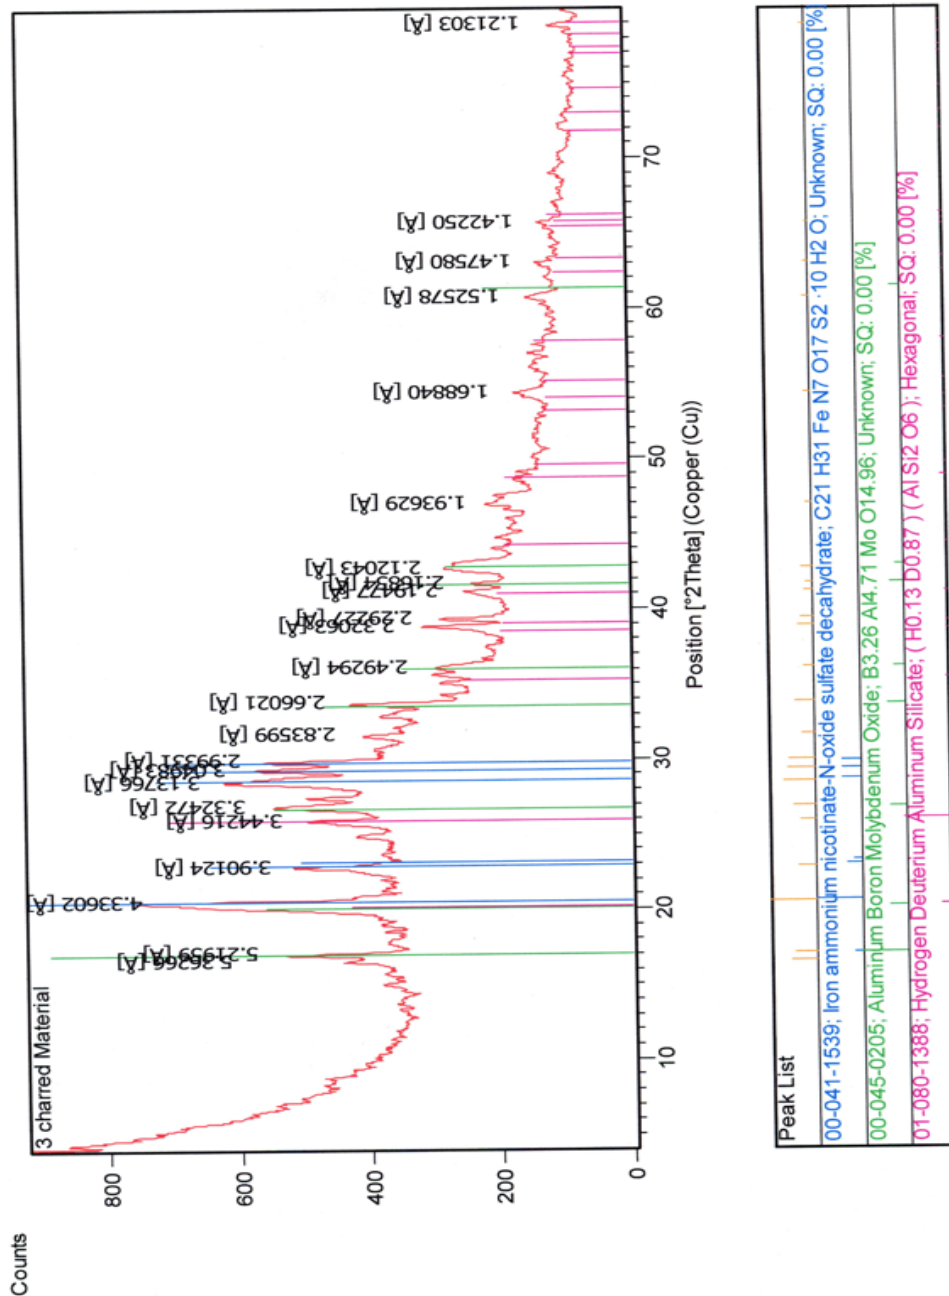
Sample No.3: Charred Material and Powder (R.H.S. SU-GBP)

The test results showed that the charred material is mainly consists of Iron ammonium Nicotinate N-Oxide Sulfate Decahydrate $C_{21}H_{31}FeN_7O_{17}S_2 \cdot 10H_2O$, Aluminum Boron Molybdenum Oxide $B_{3.26}Al_{4.71}MoO_{14.96}$ and Hydrogen Deuterium Aluminum Silicate $(H_{0.13}D_{0.87})(AlSi_2O_6)$.

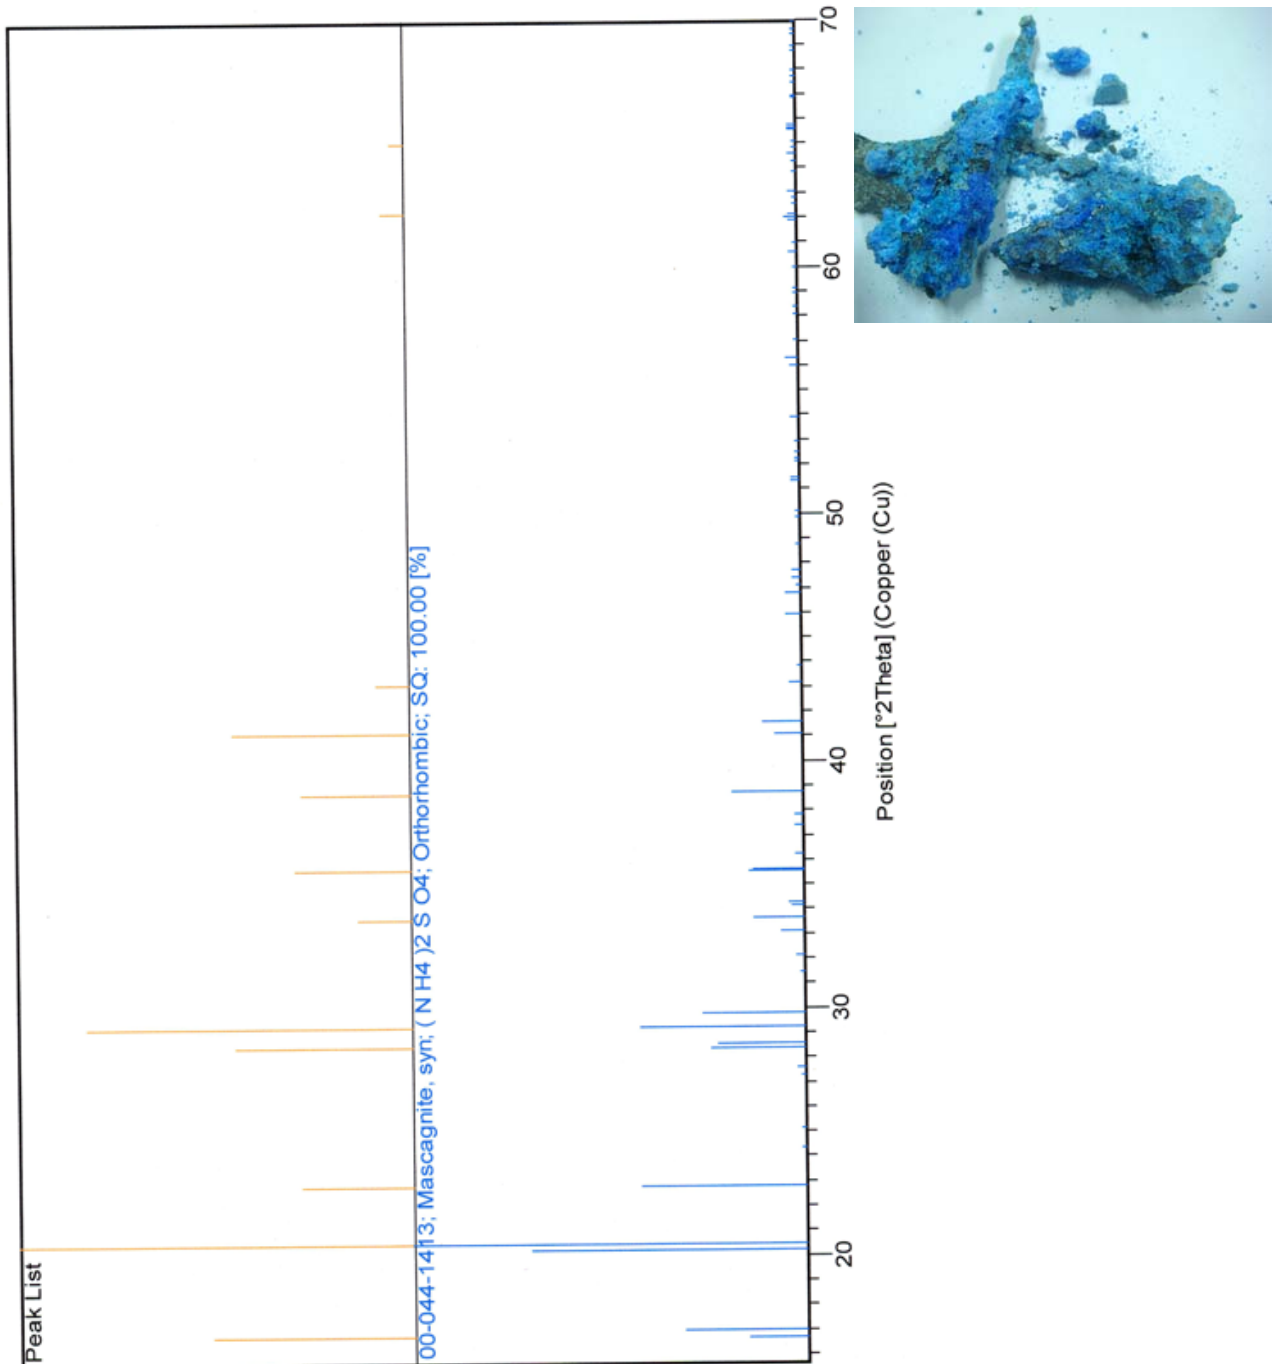
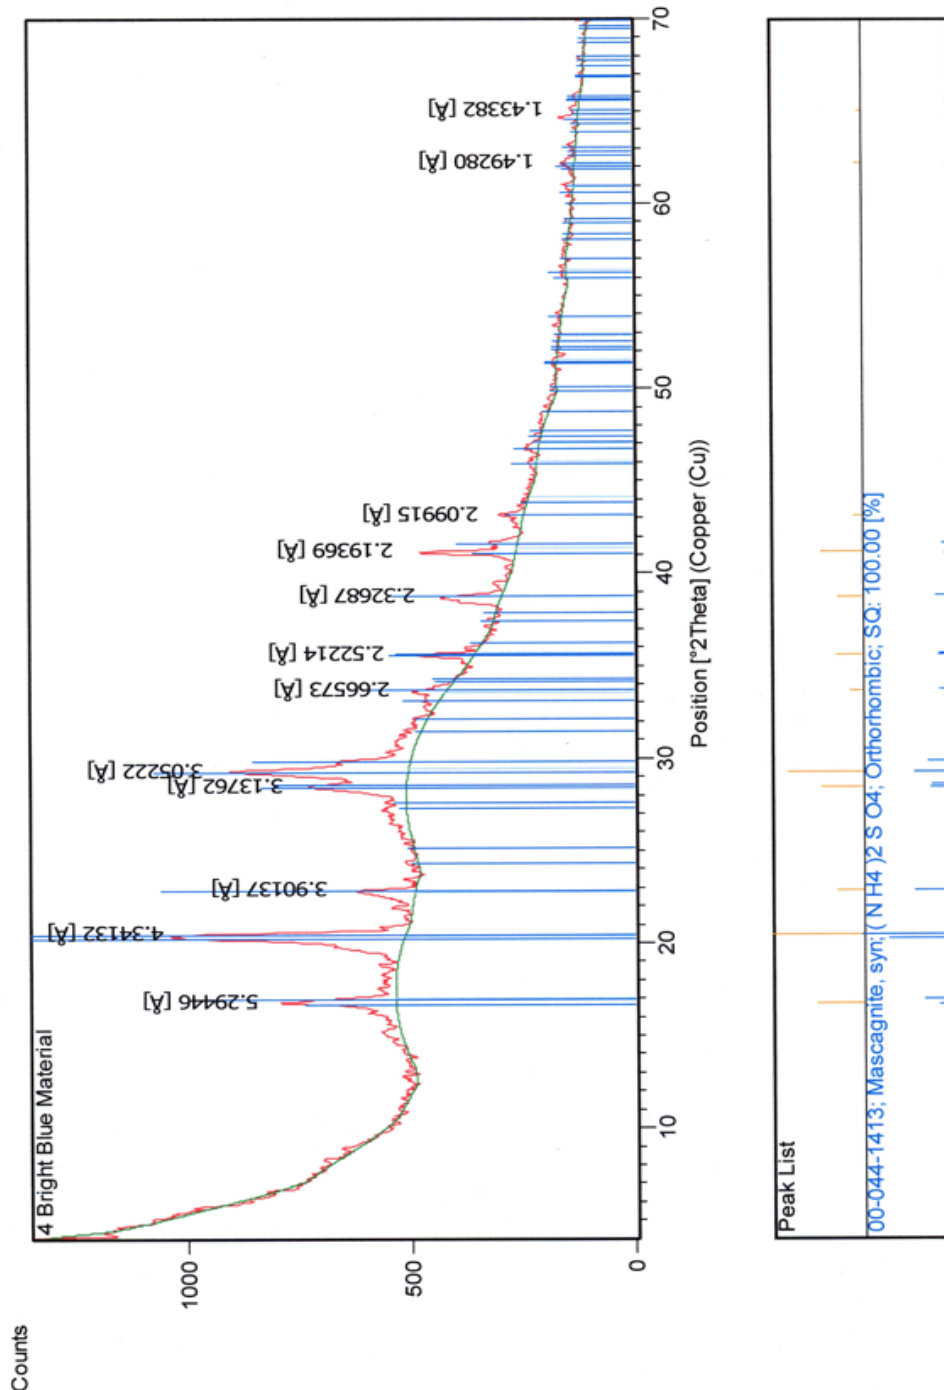
Sample No.4: Bright Blue Material (Flight Deck R.H.S. AFT of Main hole Adjacent to Wiring SU-GBP)

The test results showed that the bright blue material is mainly consists of Mascagnite $(\text{NH}_4)_2\text{SO}_4$.
